**Stream Environment Zone Report
For Tahoe Valley Area Plan**

CSLT Project: Tahoe Valley Area Plan

Prepared by: Phil Scoles, CPSS
Terra Science, Inc.
4710 S.W. Kelly Avenue, Portland, OR 97239
Ph: 503-274-2100 Email: pscoles@terrascience.com

Report Date: July 2014

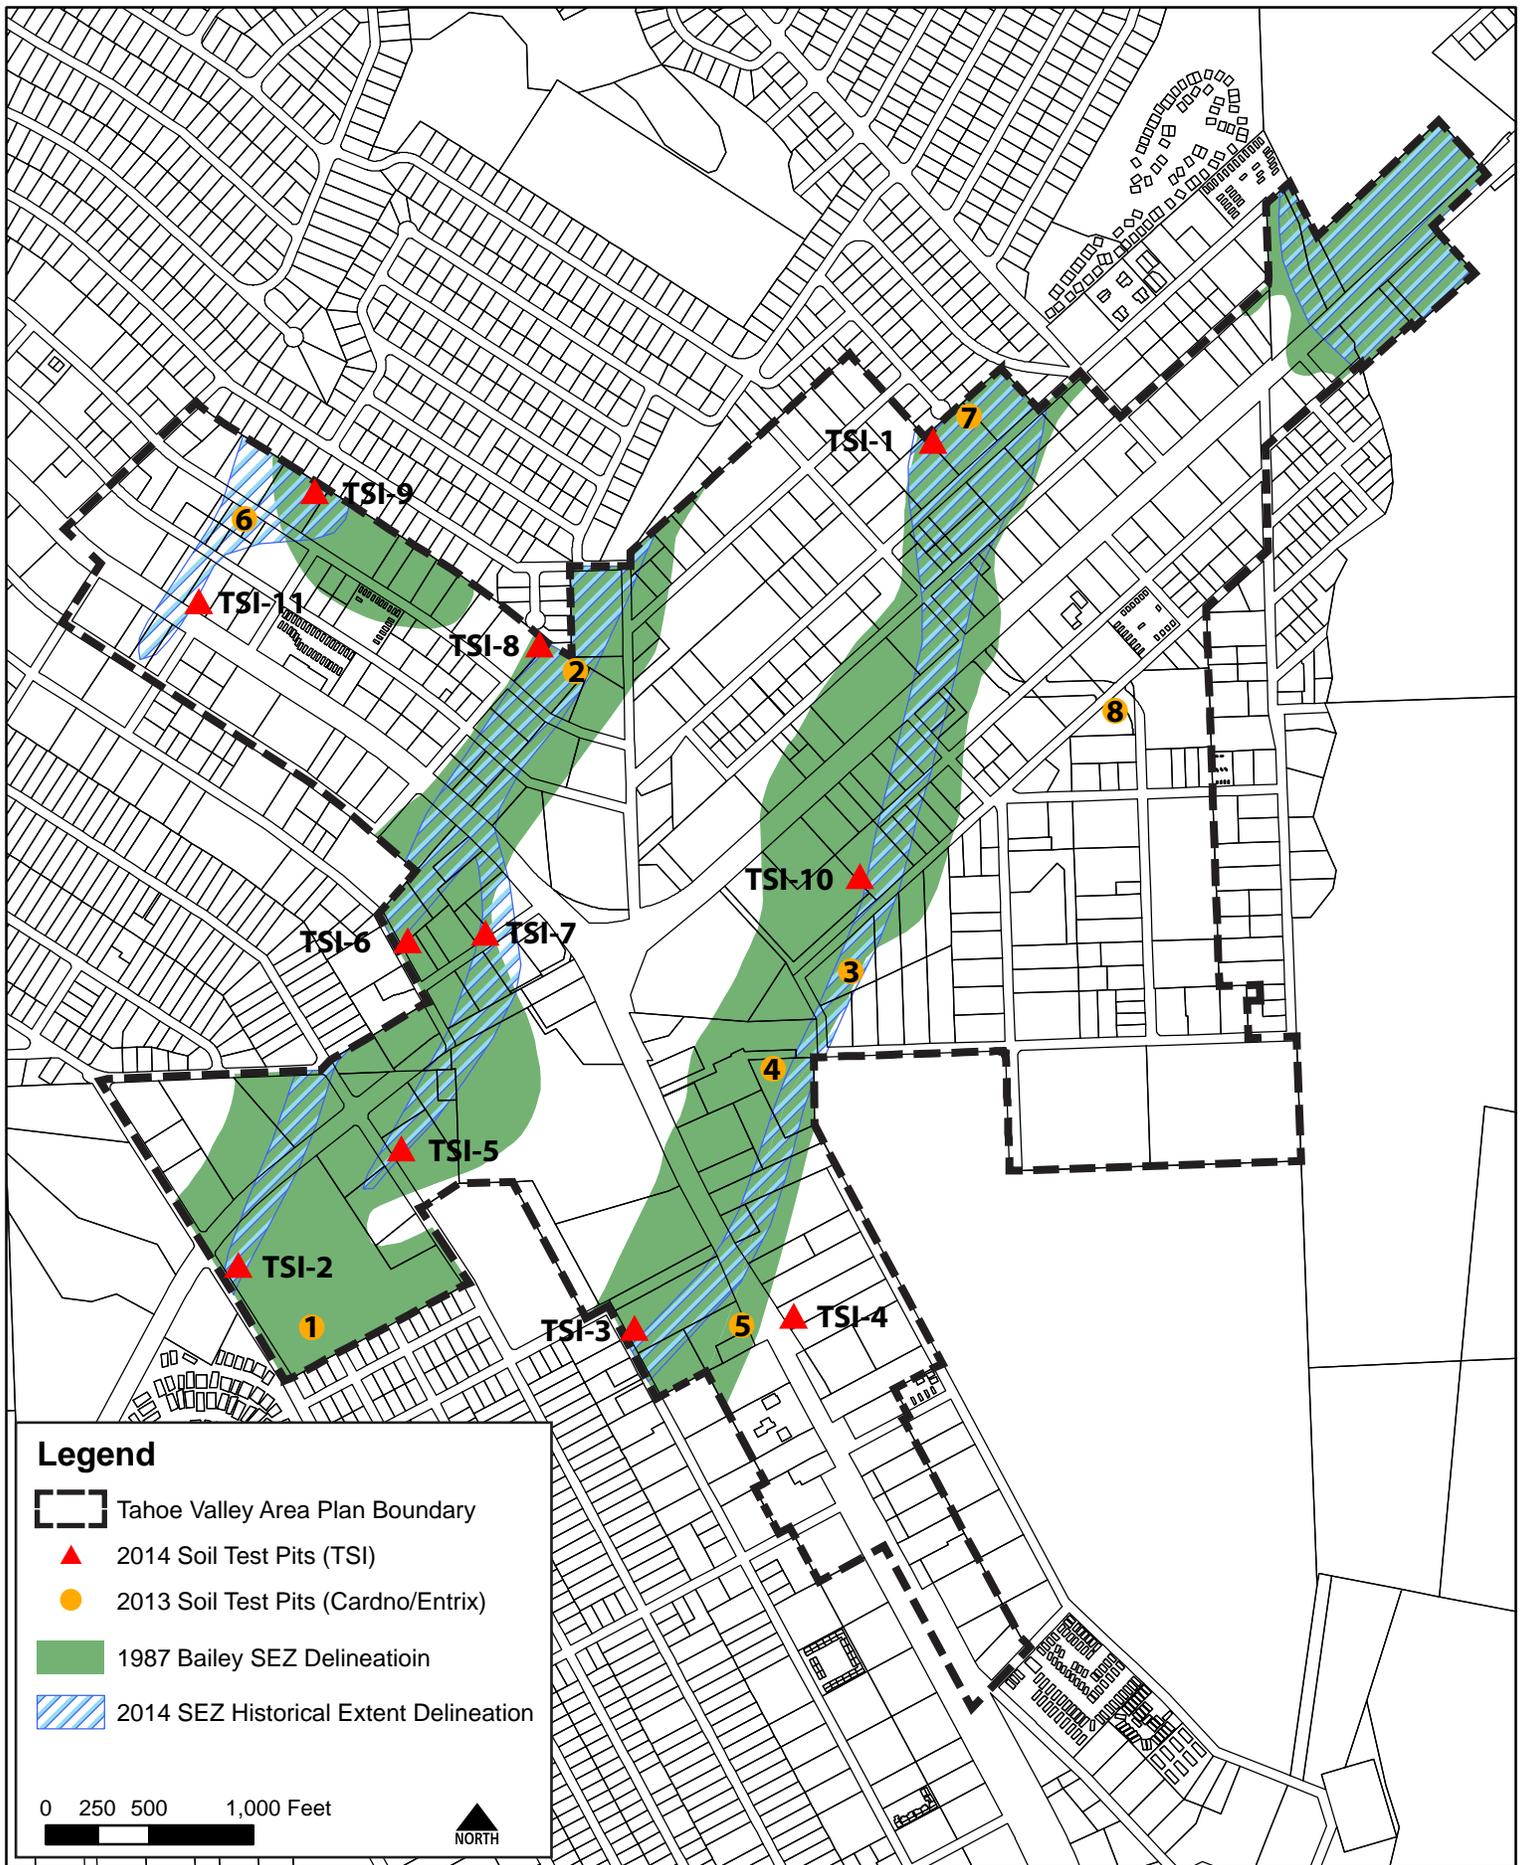
Figure 4
 2014 Mapping of Historic SEZ Extent
 Stream Zone Report for the Tahoe Valley Area Plan

Figure 4 shows the historical extent of SEZ within the Tahoe Valley Area Plan study zone. For regulatory purposes, TRPA relies upon the historical SEZ mapping extent (rather than current conditions). Such mapping verifies that the study area contained the same four SEZ complexes, as described in Section 2 of this report. These SEZs were sustained by a combination of rainfall, snowmelt and seasonal high water table. They were historically wettest in winter and spring. Except for the lower portions of the Upper Truckee flood plain, these SEZs became dry in summer when the elevation of the seasonal water table would drop in response to increasing evapotranspiration and decreasing rainfall. The following table compares the SEZ acreages determined by this report to currently adopted, TRPA land capability maps (Bailey Class 1b).

Figures 4 and 5 in Appendix A show the historic and current SEZ extent as determined by the TSI and Cardno ENTRIX investigations. The maps were prepared in AutoCAD, using linework transcribed from field maps (aerials and parcel maps). Such SEZ mapping utilized multiple parameters to assure accurate boundaries, particularly for situations having naturalistic conditions. Said differently, the refined SEZ mapping is the product of several layers of investigation, not reliance only soils and/or vegetation observations. In addition, the refined SEZ mapping reflects over 60 hours of field examination for the 320 acre study area. Such effort is substantially greater and more detailed than previous soil mapping and vegetation observations for the same area.

Without the aid of a time machine, it is impossible to positively assert that the refined historical SEZ extent met criteria in Chapter 53 of TRPA Code of Ordinances. Still, SEZs are the product of changes in natural landforms, presence of seasonal high water table, and a plant community typically adapted to seasonally moist to wet soil conditions. Over the span of almost 75 years (1940 to present), the natural landforms in the TVAP have been modified in some places and not in others. There is sufficient number of locations having intact natural landforms that a qualified professional can “stitch together” the historic drainage patterns. Similarly, a qualified soil scientist can typically differentiate between natural and disturbed/created soils, as well as conclude on presence/absence of a seasonal high water table. And using current and historical aerial images, it is possible to track changes in vegetative cover, tonal patterns and land use. Consequently, the refined historic SEZ extent shown on Figure 4 is reliable and well documented.

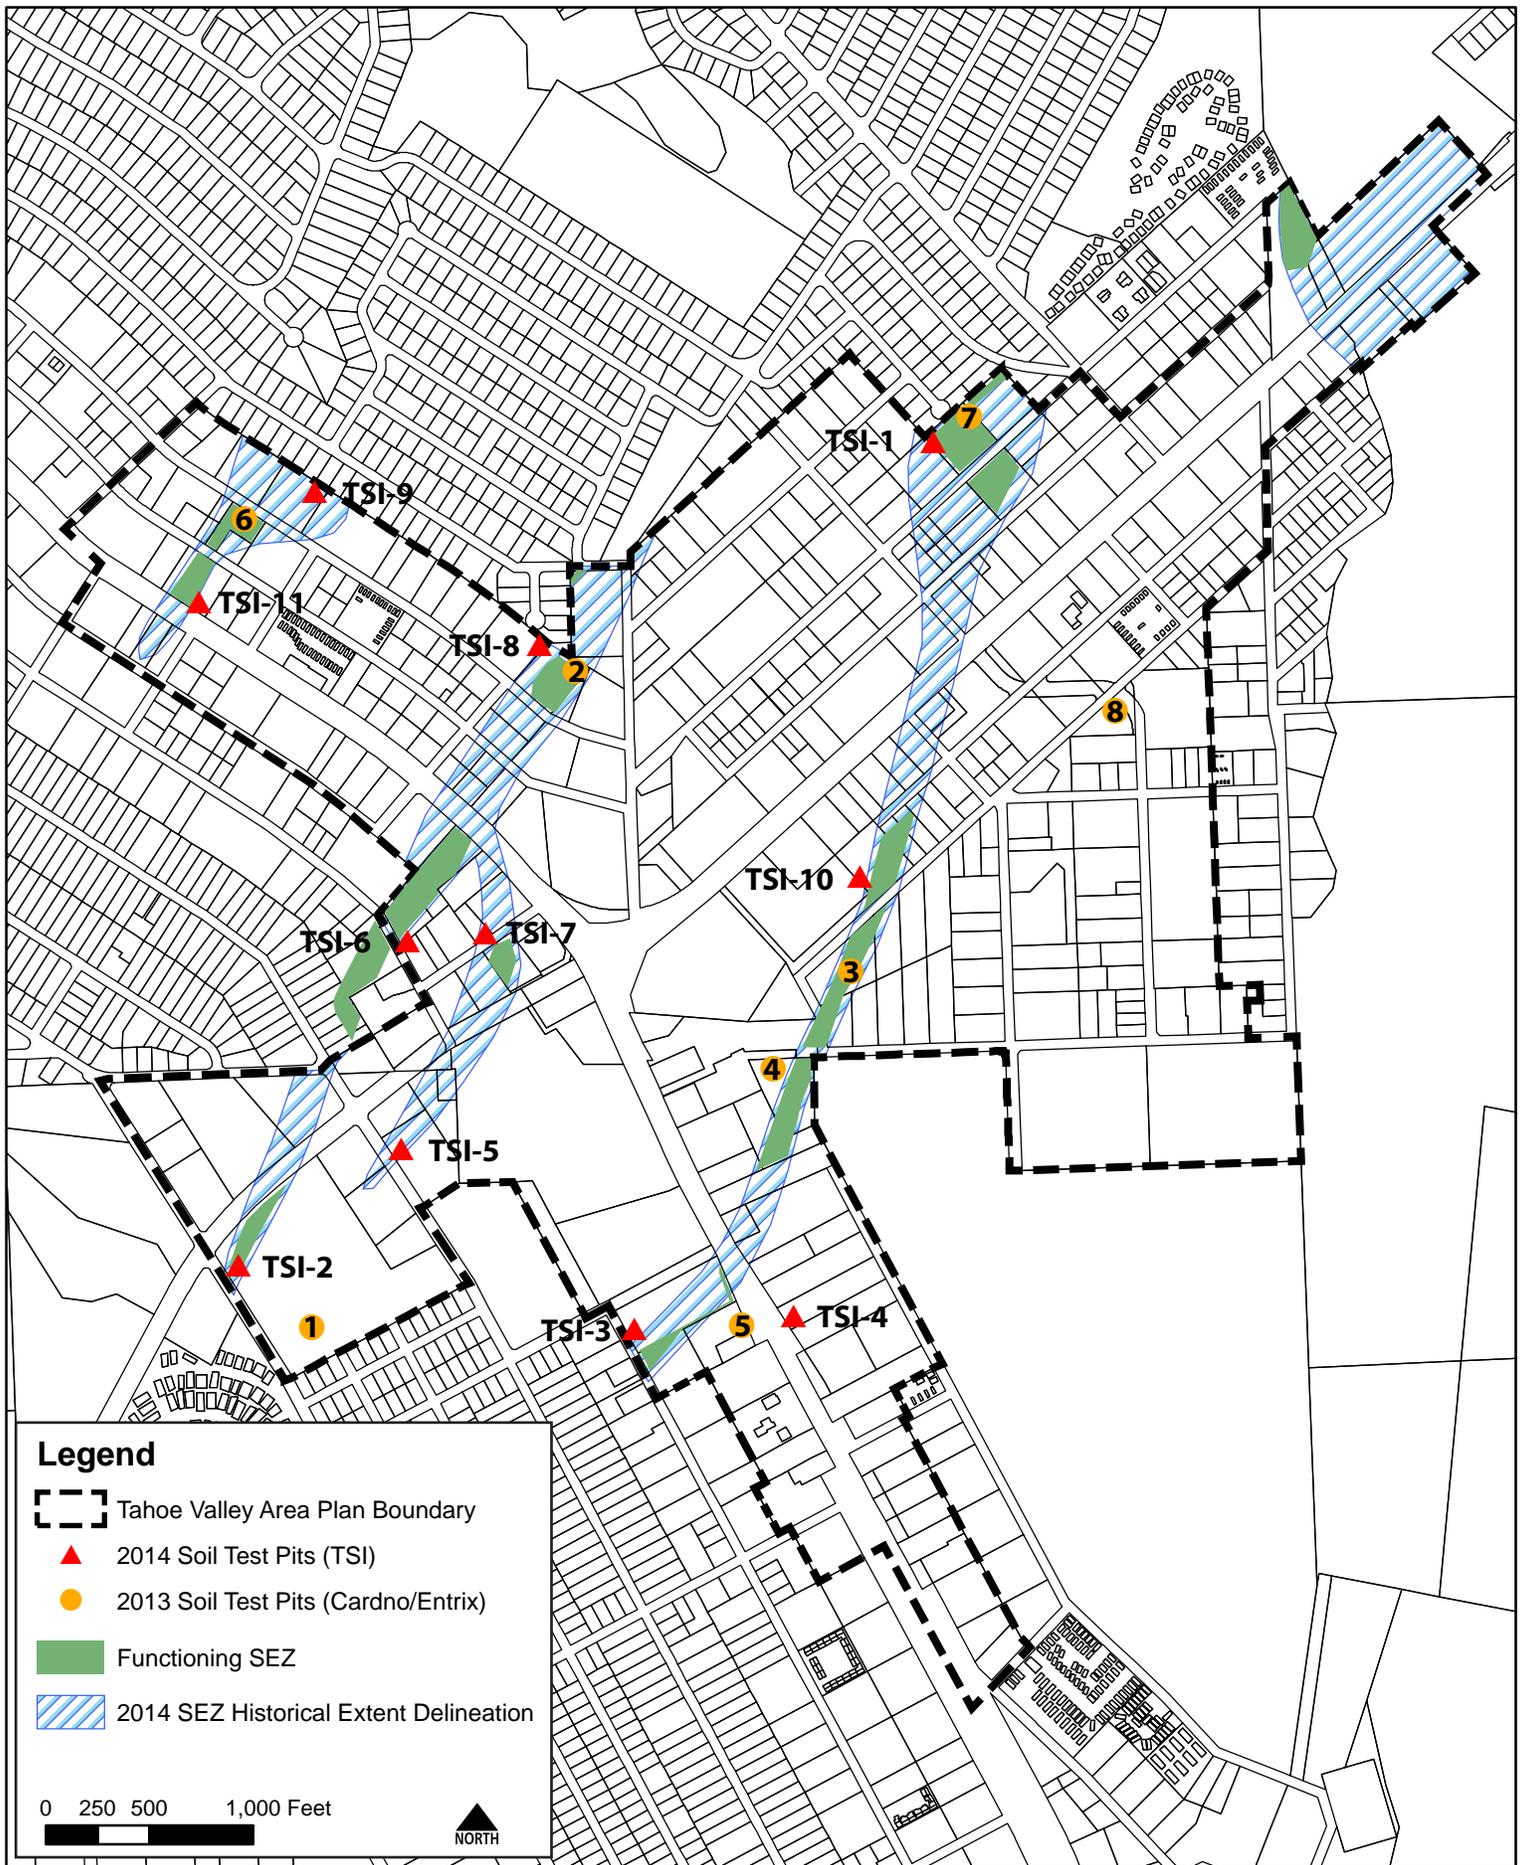
Figure 5
 2014 Mapping of Current (Vegetated) SEZ Extent
 Stream Zone Report for the Tahoe Valley Area Plan

Figure 5 shows the current extent of vegetated SEZ that likely meets the criterion specified in TRPA Chapter 53. That is, the field investigation for this report confirmed presence of key and/or secondary indicators for each of these polygons. Specifically, vegetated SEZs are differentiated from adjacent uplands on the basis of topographic setting, plant community, soil conditions, water table in the upper part, and similar attributes. It is self-evident that only scattered remnants of SEZ exist (when compared to the historic SEZ extent). Some of the remnants are hydrologically connected, while others are isolated or terminate at a storm sewer or edge of urban development.

The field investigation also confirmed that the cross-hatched areas are places where historic SEZ was filled, ditched, or otherwise removed and no longer meet SEZ identification criteria. Further analysis, such as shallow hydrology monitoring, is necessary to determine potential for restoring SEZ function, since field conditions differ on basis of adjacent land use, presence of underground utilities, presence/absence of old fill material, opportunity to receive treated storm water, and related factors. NOTE: The cross-hatched areas in Figure 5 do not infer that such lands have been administratively changed to a different land capability classification using the man-modified procedures. TRPA maintains a database of site-specific locations where man-modified procedures have been applied and approved by a hearings officer.

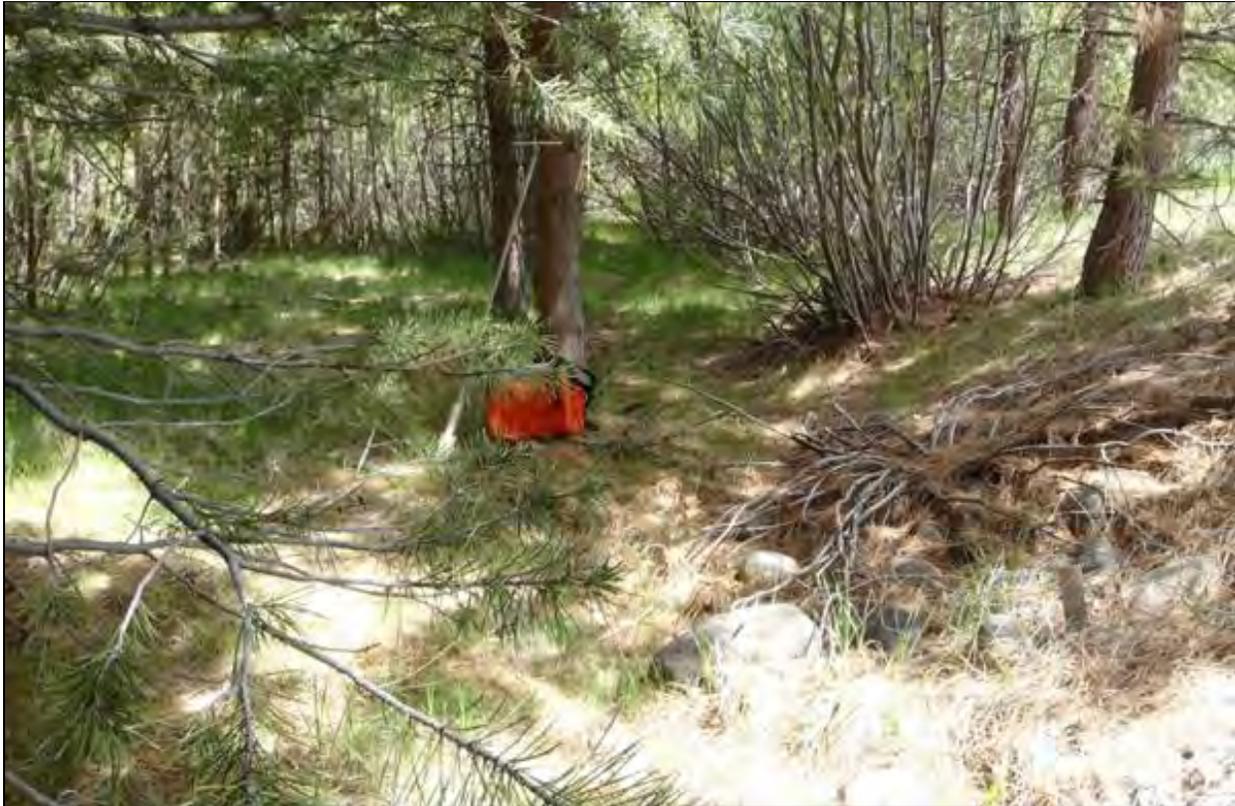
Photo D-1A – View to east at sample location TSI-1 (SEZ). Sample location situate to left of fill slope (transitions up to fill pad to south on neighboring lot).

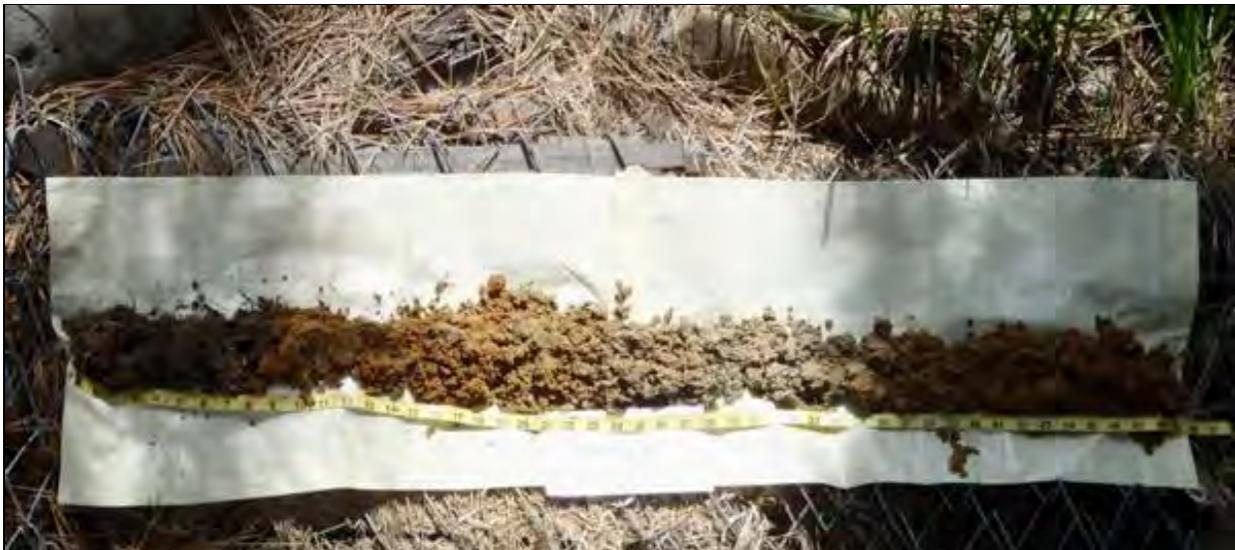
Photo D-1B – Soil profile at TSI-1 (SEZ). Soil is extensively mottled in upper part and becomes grayer at 19- to 35-inch depth.

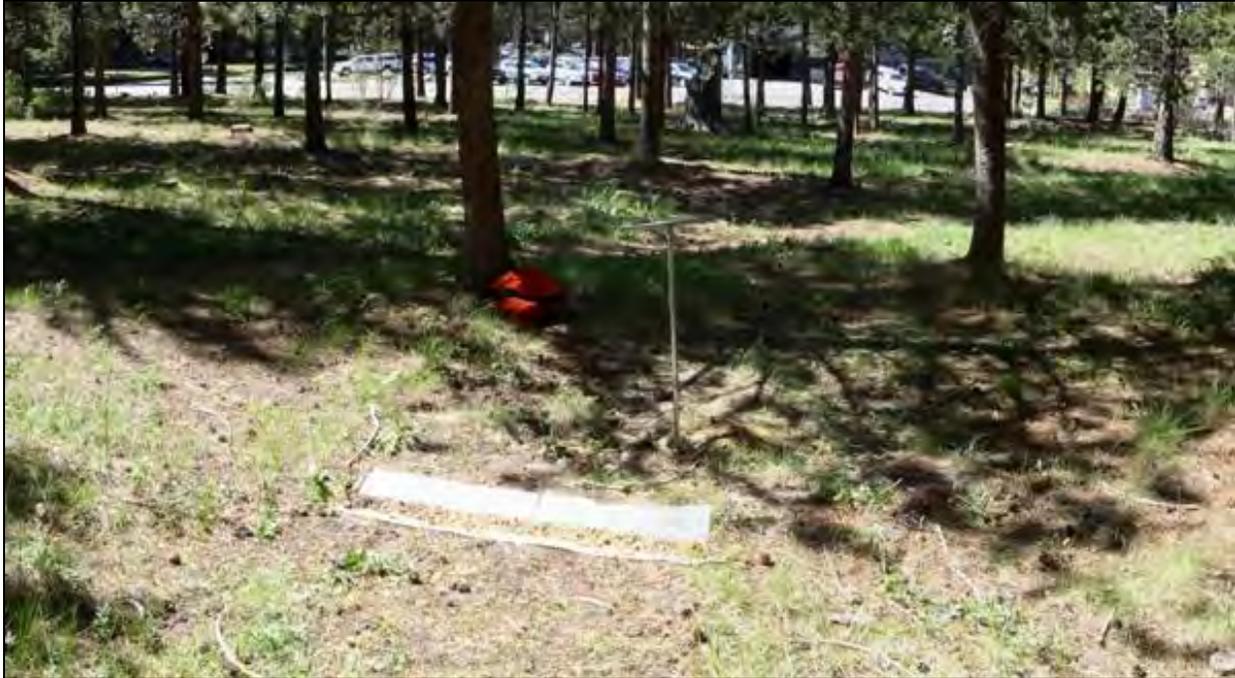
Photo D-2A – View to southeast at sample location TSI-2 (SEZ). Sample location situated in center of subtle swale (higher topography to north and south).

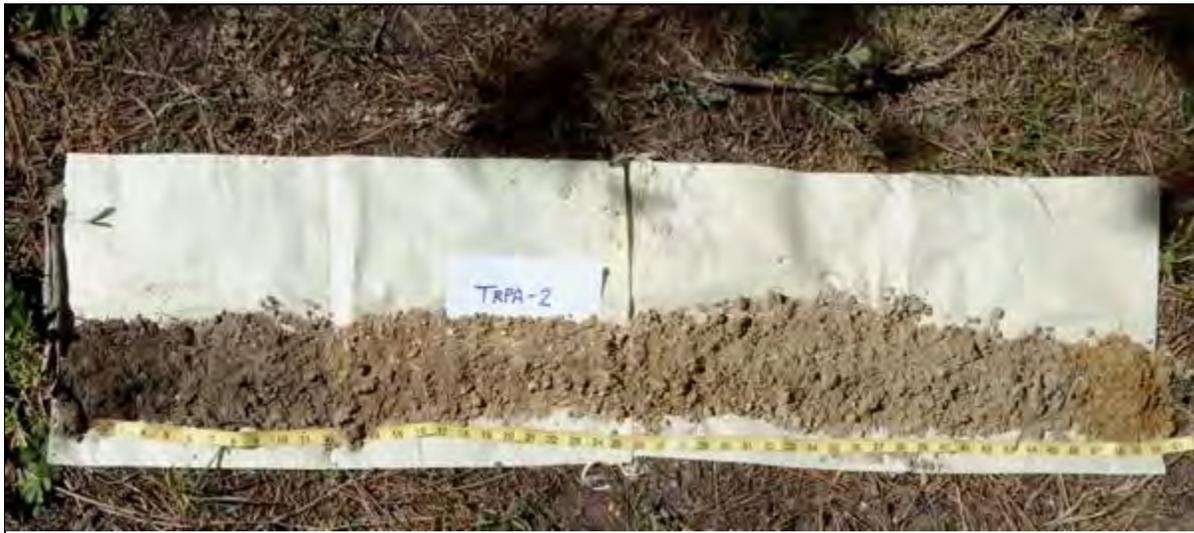
Photo D-2B – Soil profile at TSI-2 (SEZ). Soil profile indicates soil location was historically wetter, but plant community indicates drier current conditions.

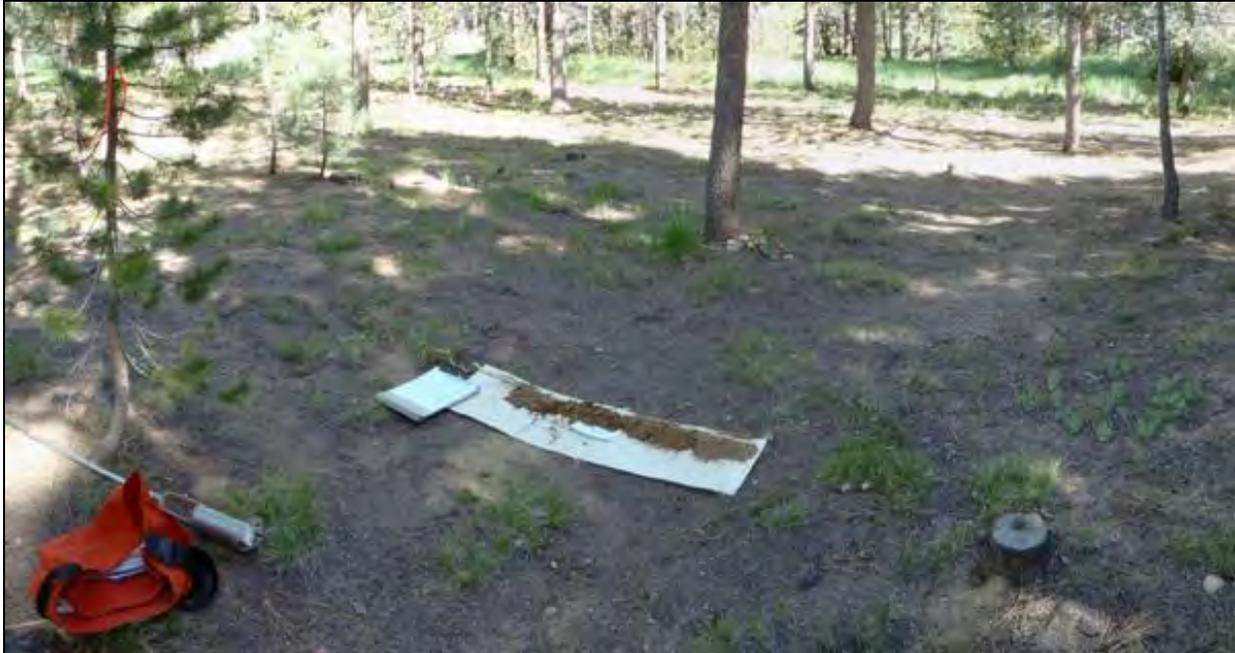
Photo D-3A – View to northeast at sample location TSI-3 (SEZ). Sample location situated in area previously filled and graded.

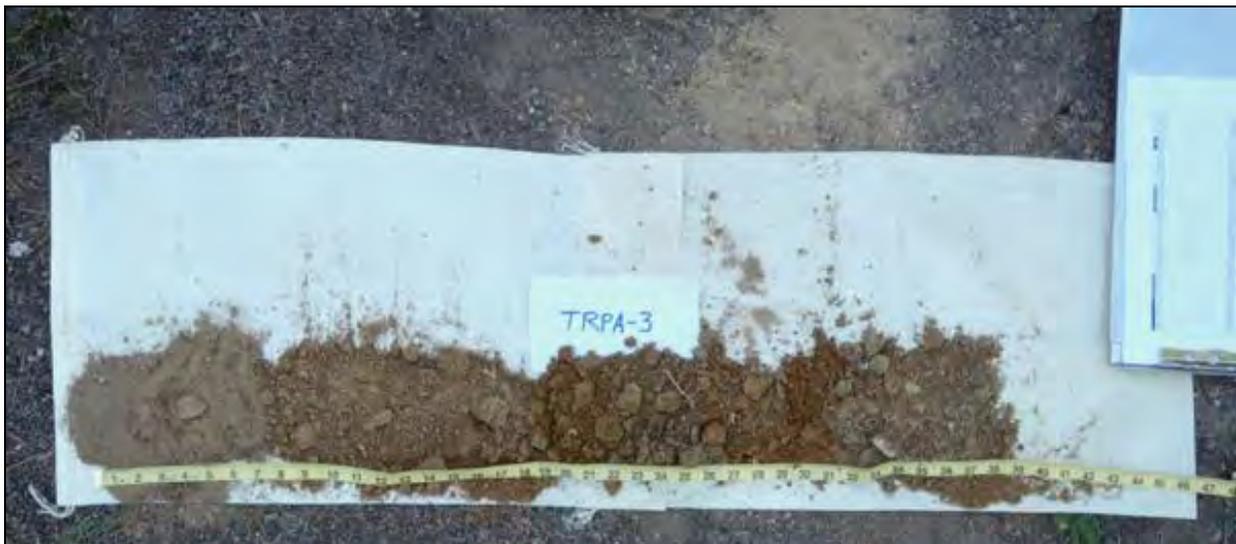
Photo D-3B – Soil profile at TSI-3 (SEZ). Soil profile indicates the upper 20 inches is fill material. The underlying soil appears to be truncated profile (topsoil removed before filled).

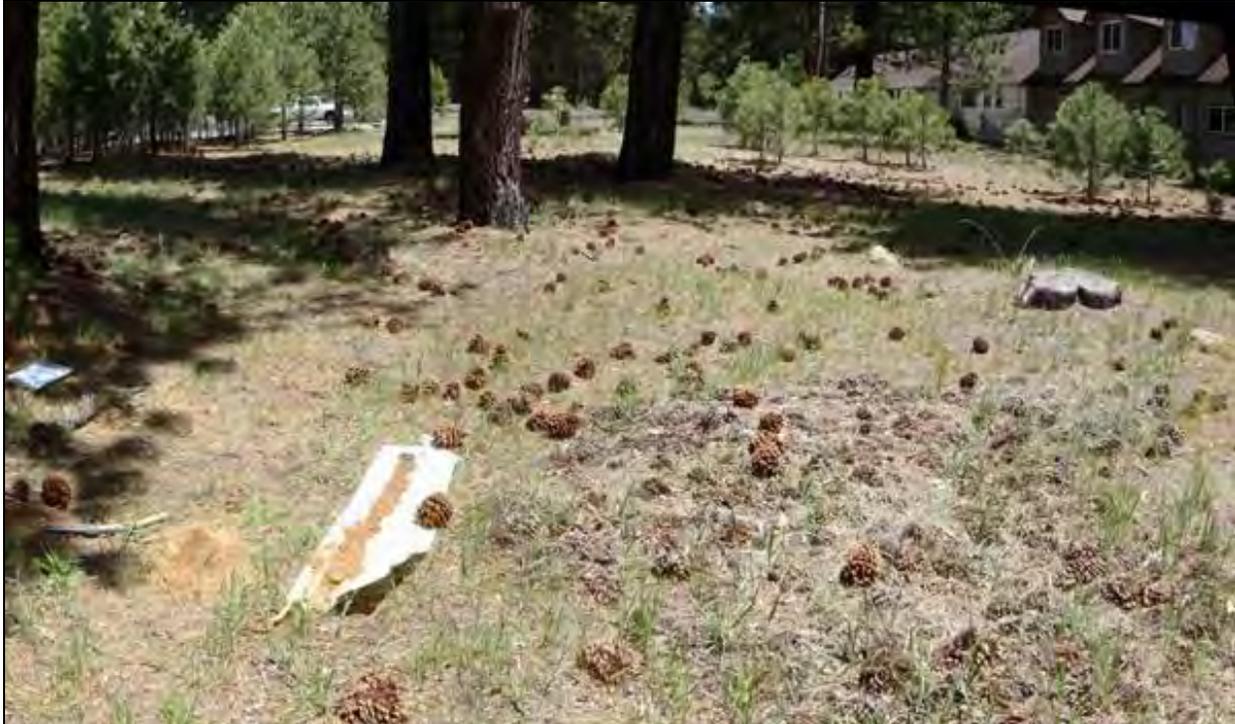
Photo D-4A – View to east at sample location TSI-4 (Upland). Sample location situated in area that has minor surface disturbance, but subsoil appears undisturbed.

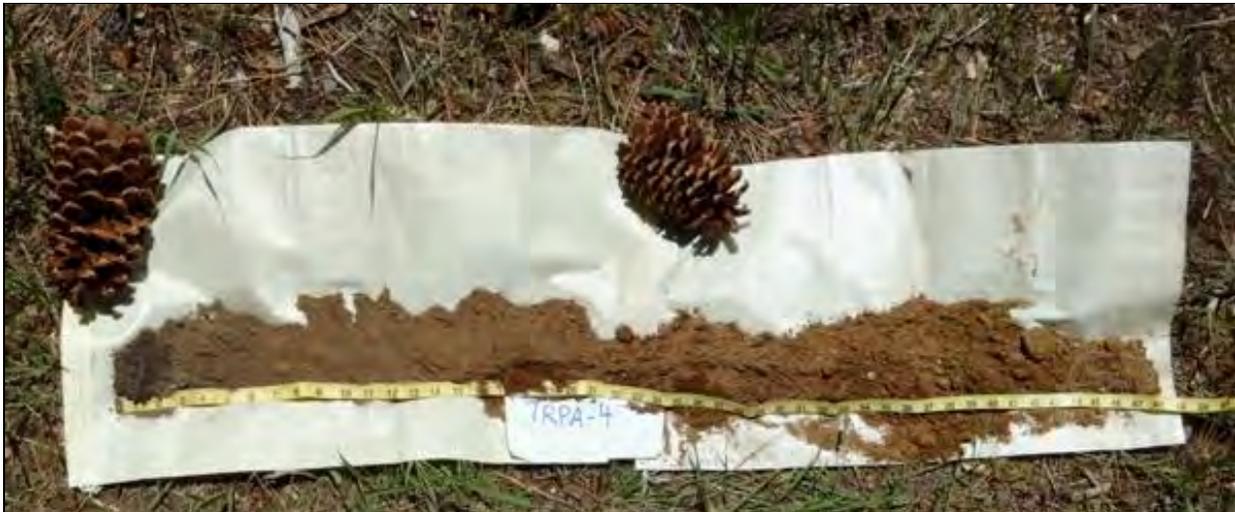
Photo D-4B – Soil profile at TSI-4 (Upland). Soil profile indicates no extended wetness in upper 49 inches.

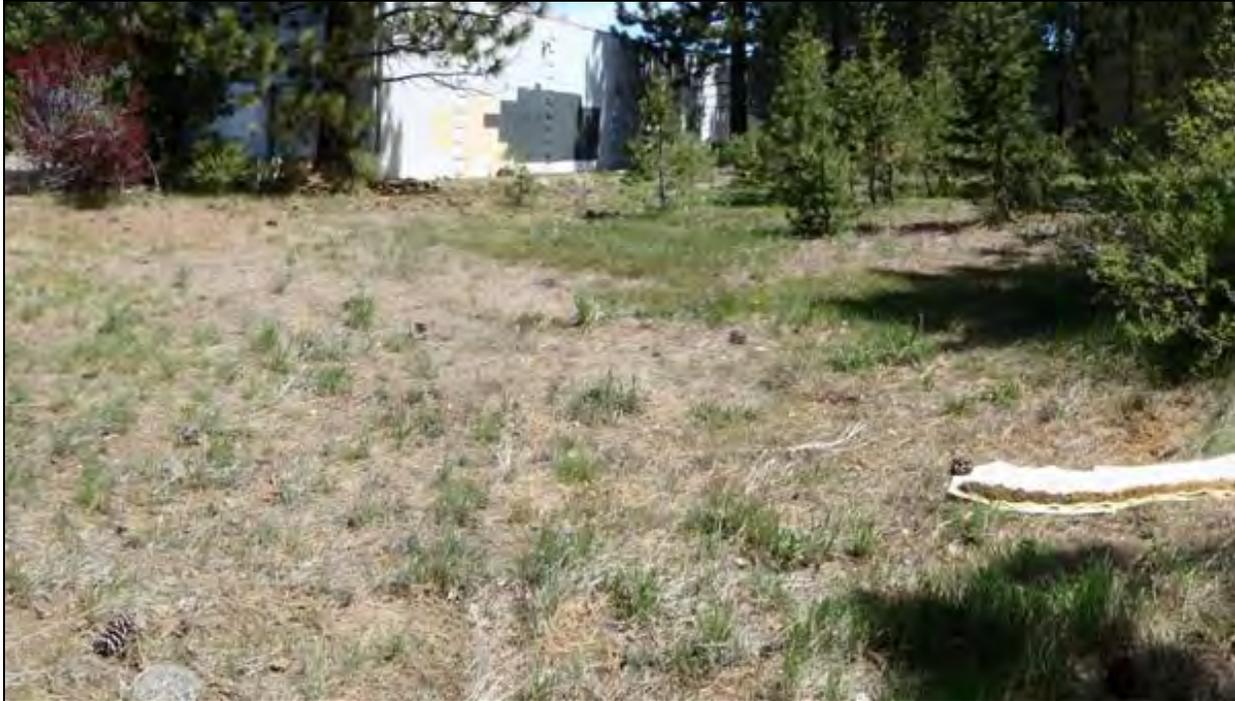
Photo D-5A – View to northeast at sample location TSI-5 (SEZ). Sample location situated subtle low spot between Tata Lane, parking lot (to south) and commercial building.

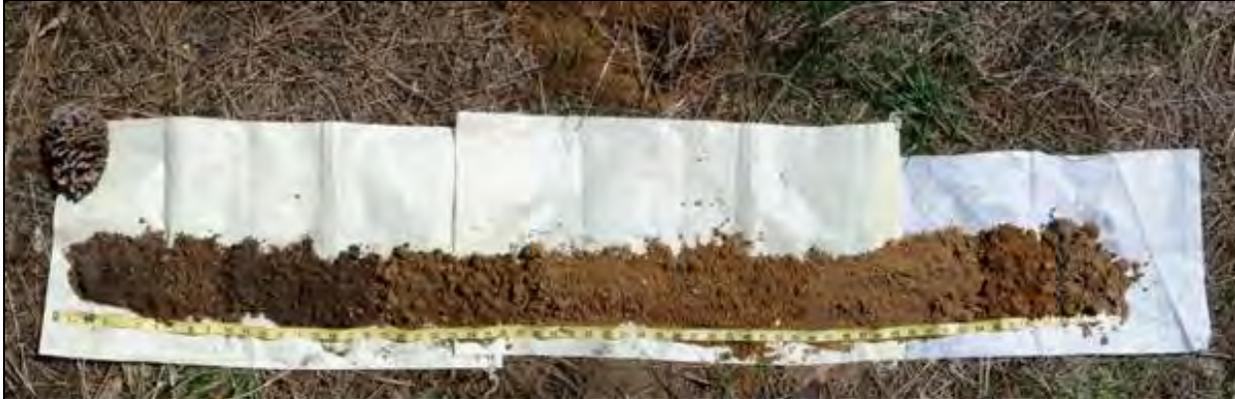
Photo D-5B – Soil profile at TSI-5 (SEZ). Soil profile indicates presence of old fill atop native soil (beginning at approximately 19 inches).

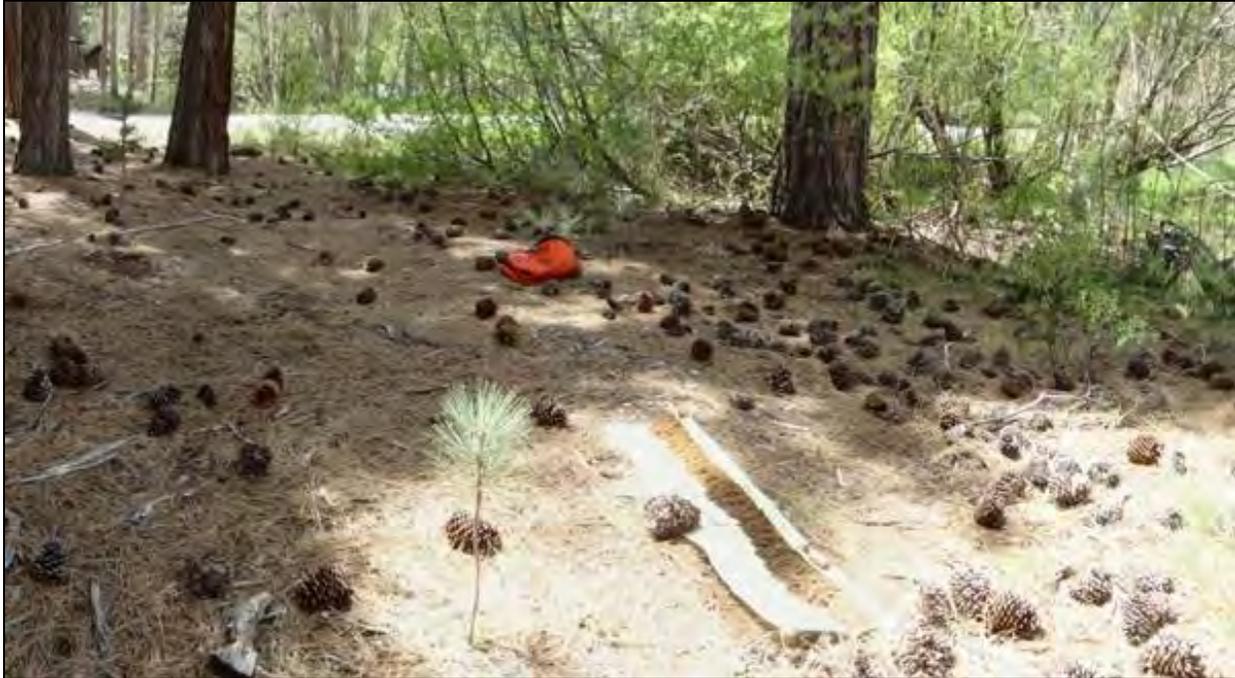
Photo D-6A – View to west at sample location TSI-6. Sample location situated northeast of Glorene Lane and northwest of Tucker Avenue, about 30 feet from SEZ edge.

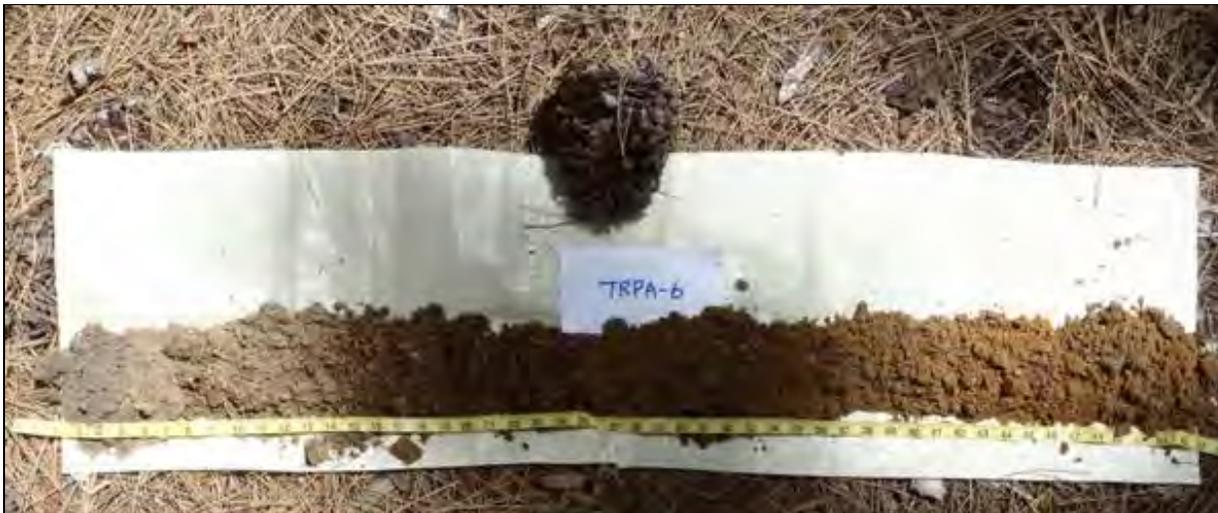
Photo D-6B – Soil profile at TSI-6 (Upland). Soil profile indicates lack of significant disturbance and lack of extended wetness in the upper 25 inches.

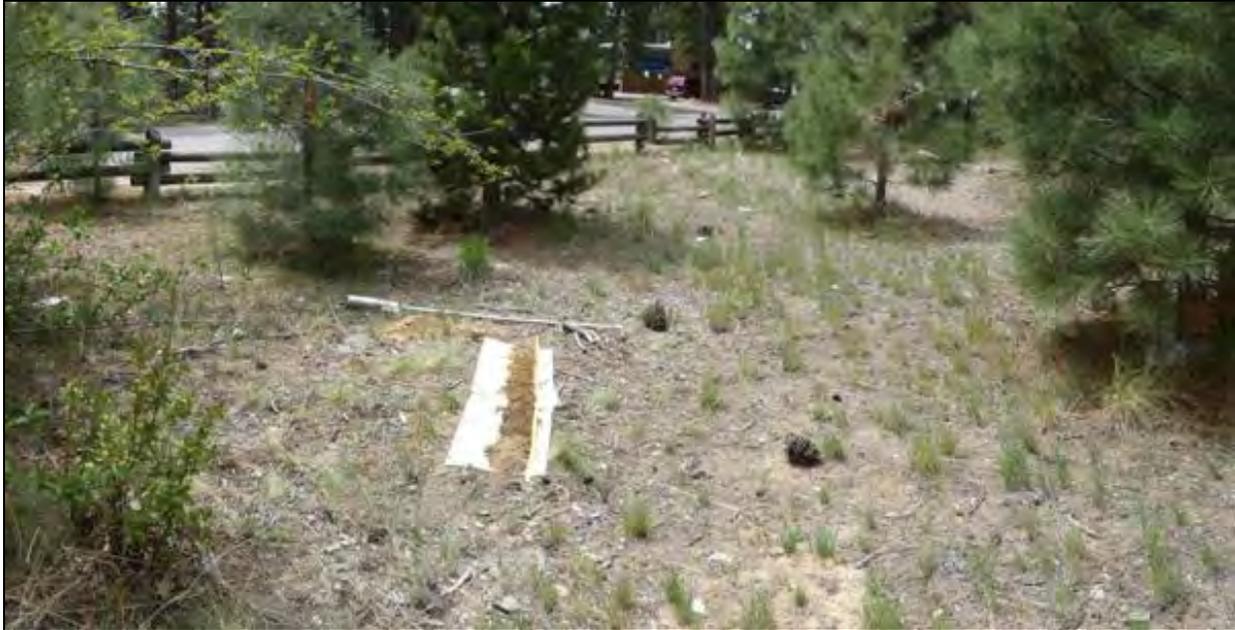
Photo D-7A – View to northeast at sample location TSI-7 (Upland). Sample location situated about 35 feet northwest of Tucker Avenue and 1 block west of Hwy. 89.

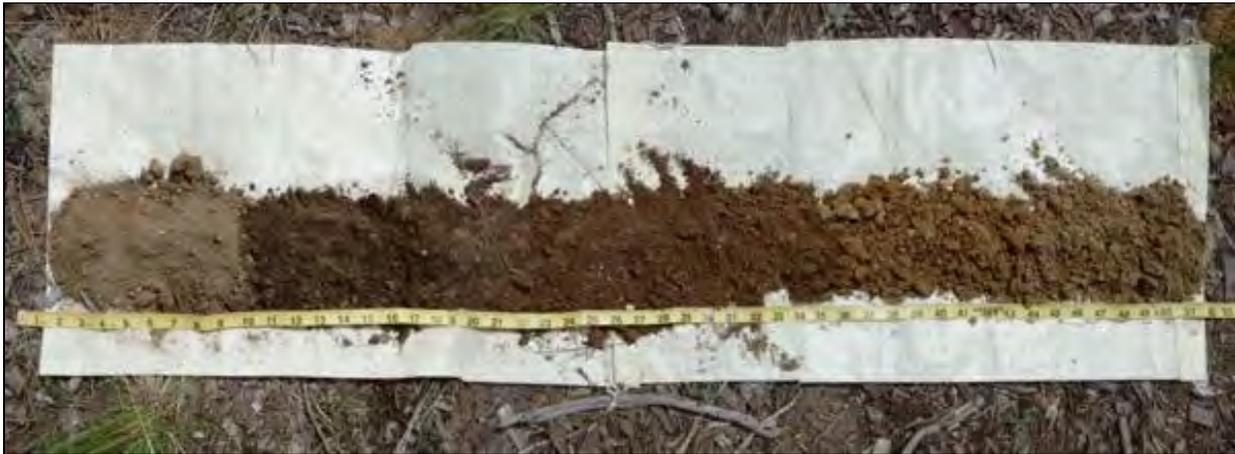
Photo D-7B – Soil profile at TSI-7 (Upland). While sample location was historically cleared (minor disturbance), profile indicates lack of extended wetness in upper 35 inches.

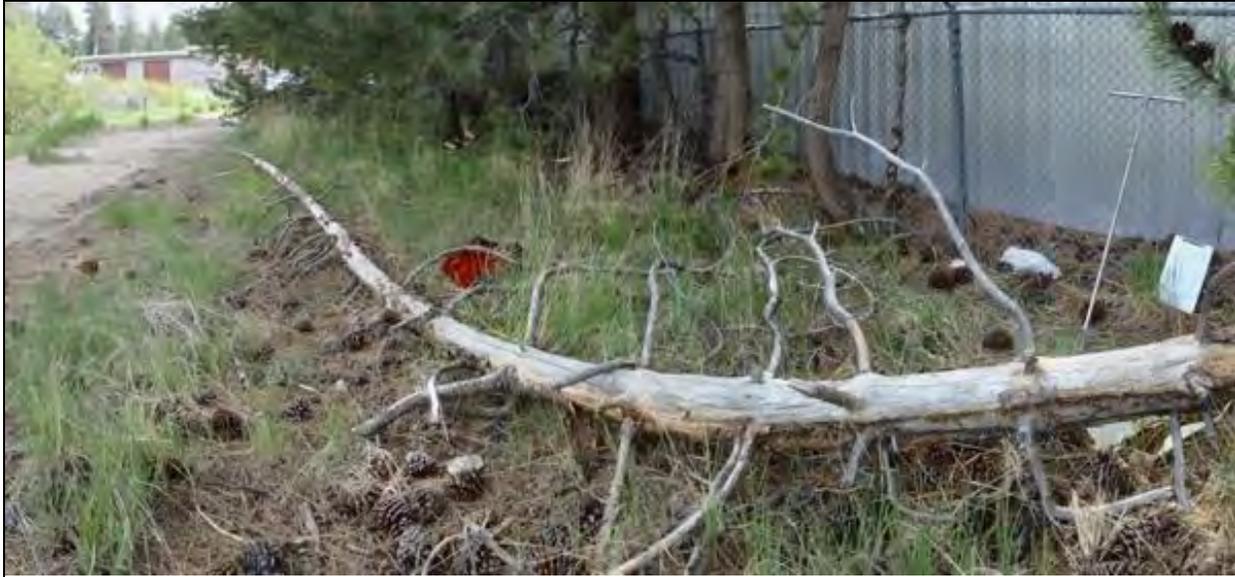
Photo D-8A – View to south at sample location TSI-8 (Upland). Sample location situated about 400 feet north of Eloise and Fifth Street intersection.

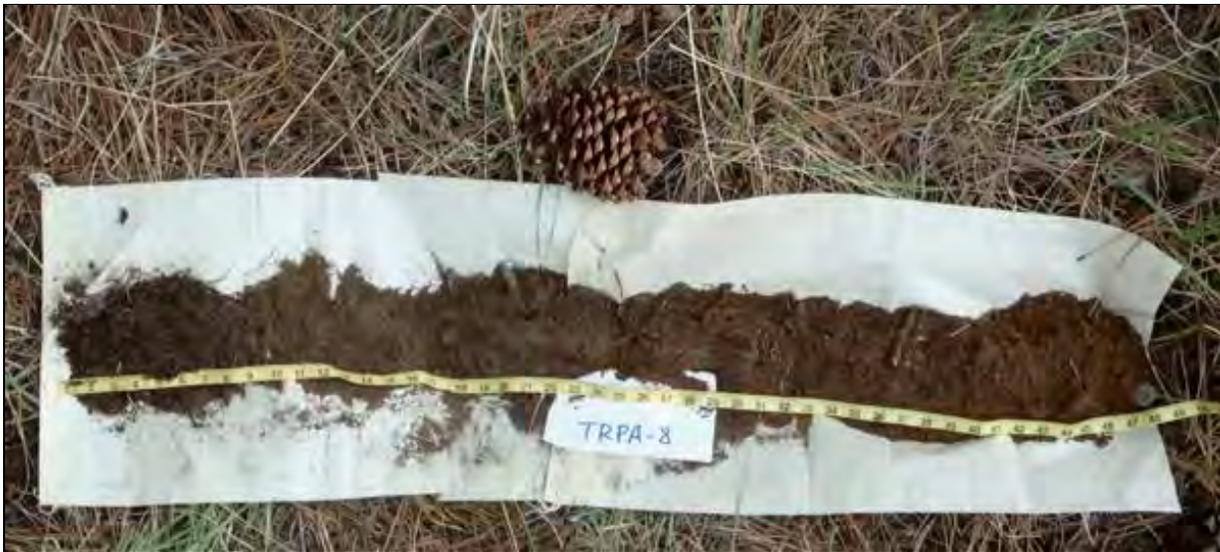
Photo D-8B – Soil profile at TSI-8 (Upland). While sample location has trees planted, profile appears undisturbed and lacks indication of extended wetness in upper 53 inches.

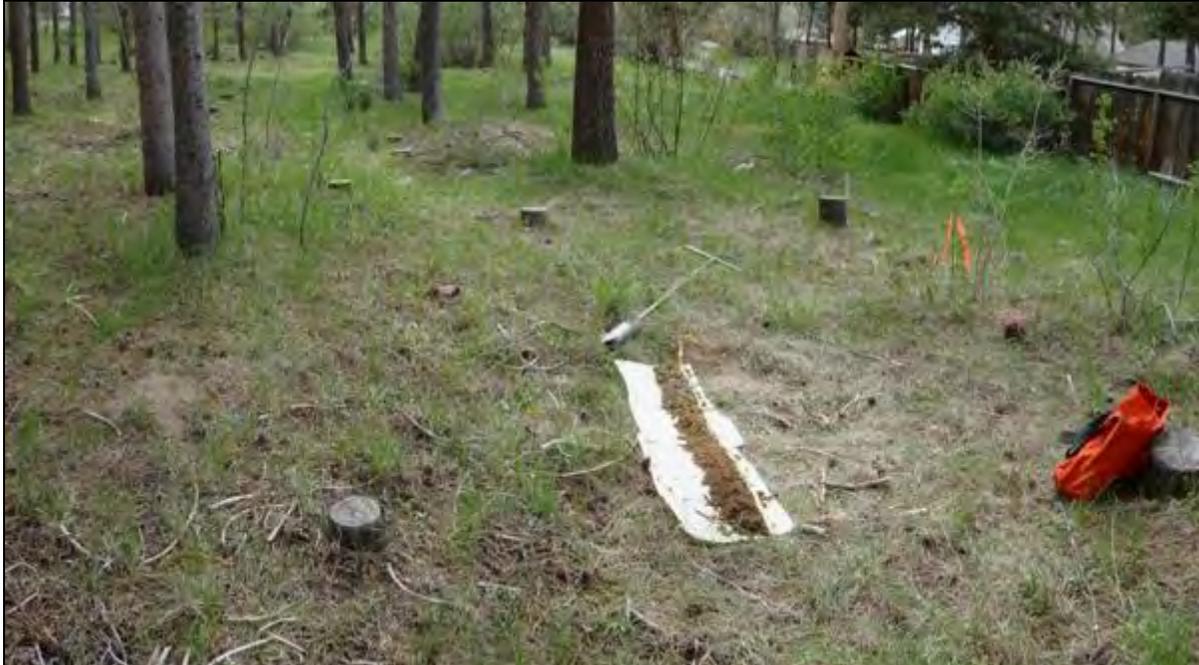
Photo D-9A – View to northwest at sample location TSI-9 (SEZ). Sample location situated about halfway between Eloise Ave. and Patricia Ln., and north of Seventh St.

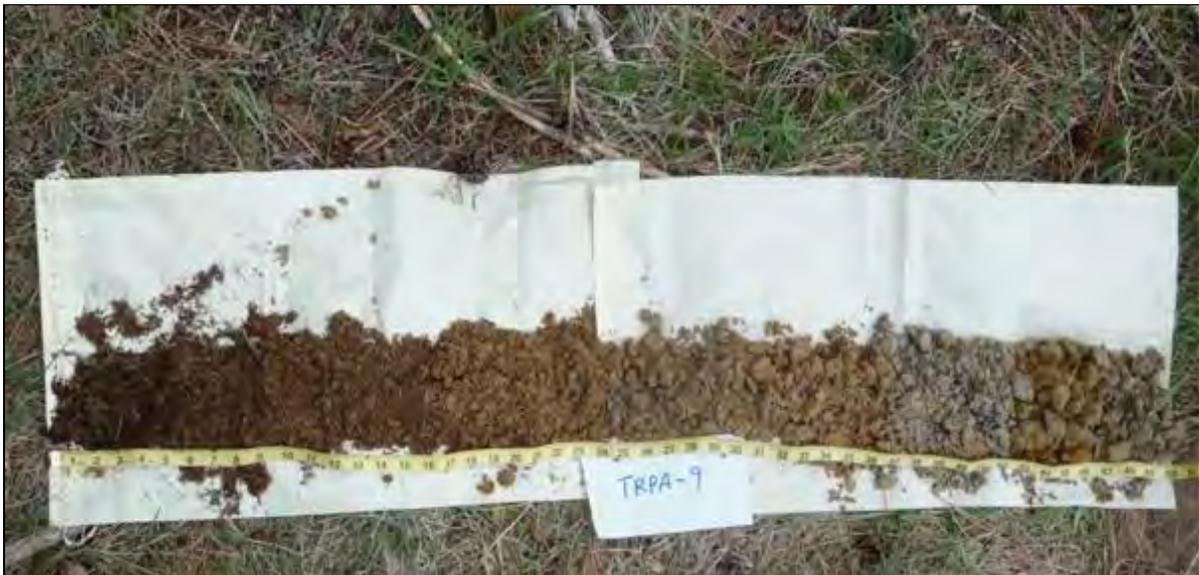
Photo D-9B – Soil profile at TSI-9 (SEZ). Soil profile indicates extended wetness rises to 24 inches, while plant community qualifies as SEZ. Hydrology monitoring recommended.

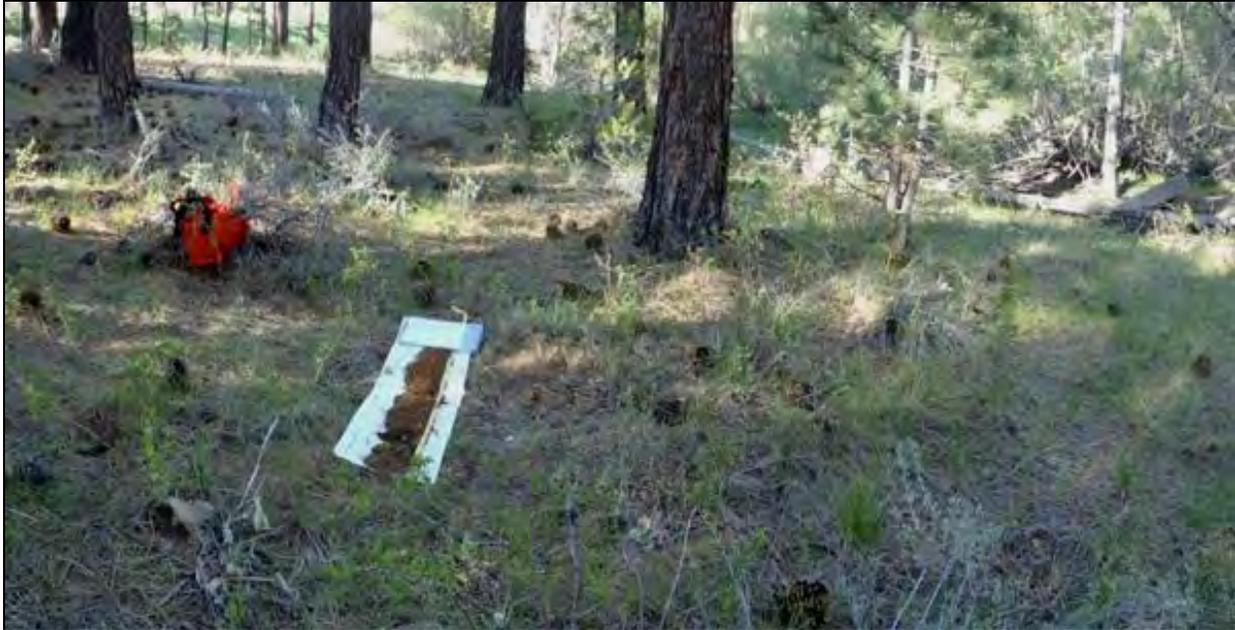
Photo D-10A – View to north at sample location TSI-10 (Upland). Sample location situated about 25 feet from SEZ (beyond right edge of photo).

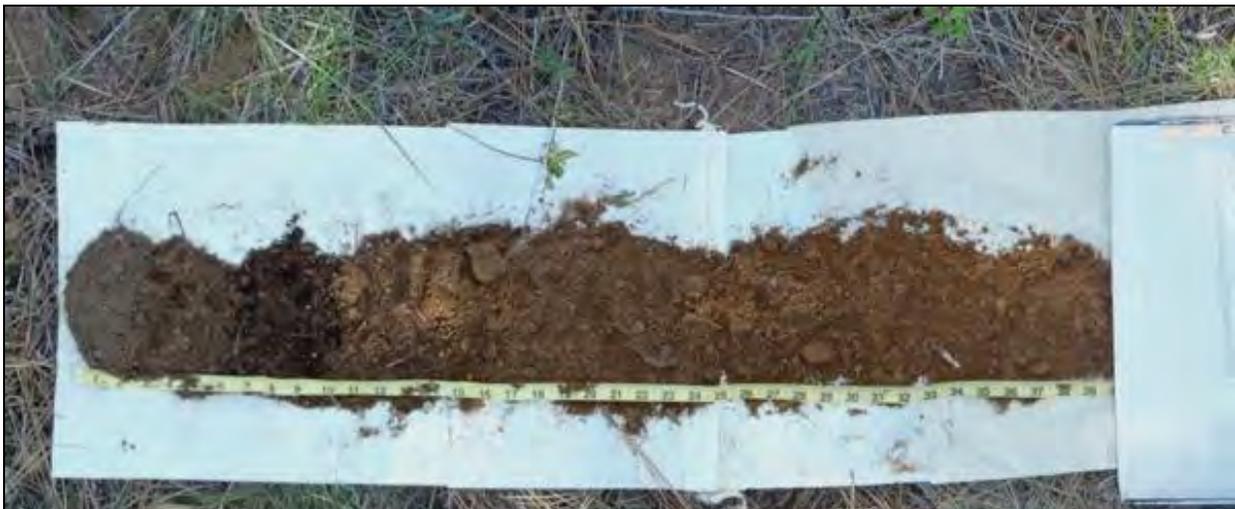
Photo D-10B – Soil profile at TSI-10 (Upland). Soil profile indicates lack of extended wetness within 39 inches of surface (rock refusal at 39 in.).
