**Stream Environment Zone Report
For Tahoe Valley Area Plan**

CSLT Project: Tahoe Valley Area Plan

Prepared by: Phil Scoles, CPSS
Terra Science, Inc.
4710 S.W. Kelly Avenue, Portland, OR 97239
Ph: 503-274-2100 Email: pscoles@terrascience.com

Report Date: July 2014

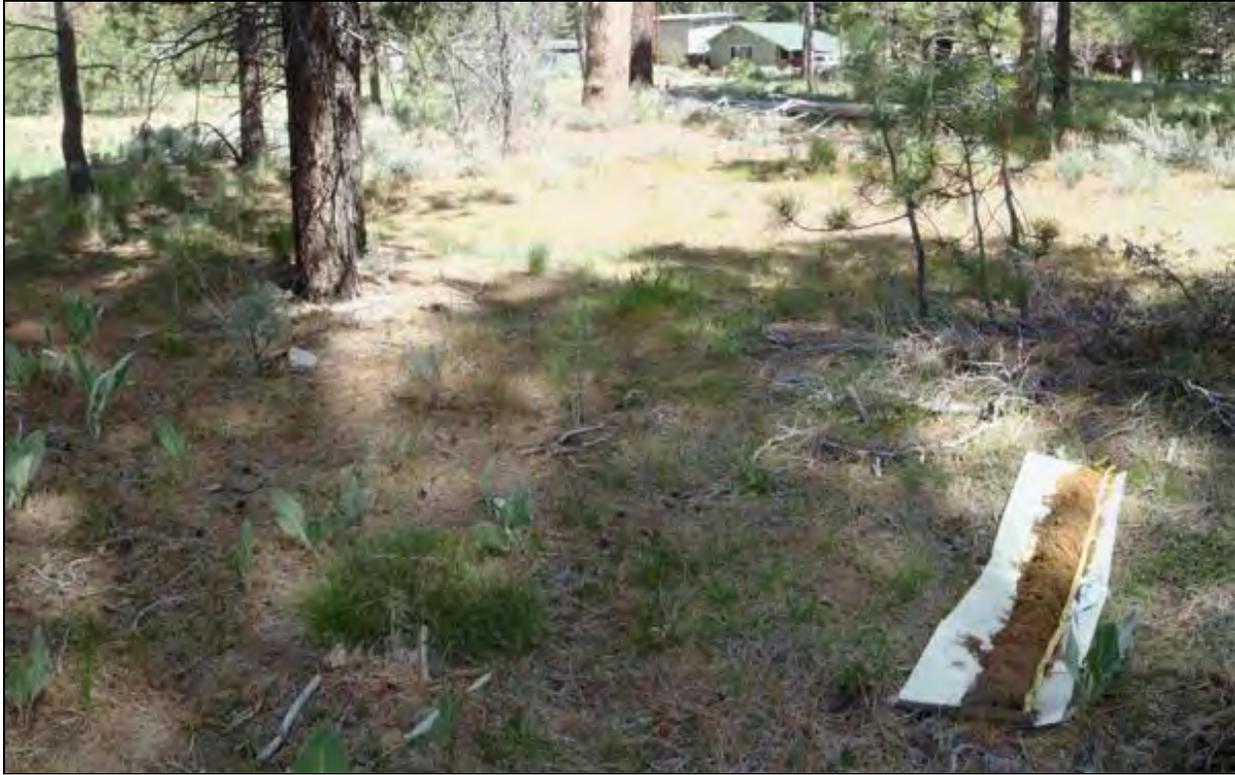
Photo D-11A – View to northeast at sample location TSI-11 (Upland). Sample location situated about 40 feet from SEZ (extreme left edge of photo).
